NASA Contractor Report 172359

# ACEE COMPOSITE STRUCTURES TECHNOLOGY

## **Papers by Douglas Aircraft Company**

DAMAGE TOLERANCE AND FAIL-SAFE TESTING  
OF THE  
DC-10 COMPOSITE VERTICAL STABILIZER  
CONTRACT NAS1-14869

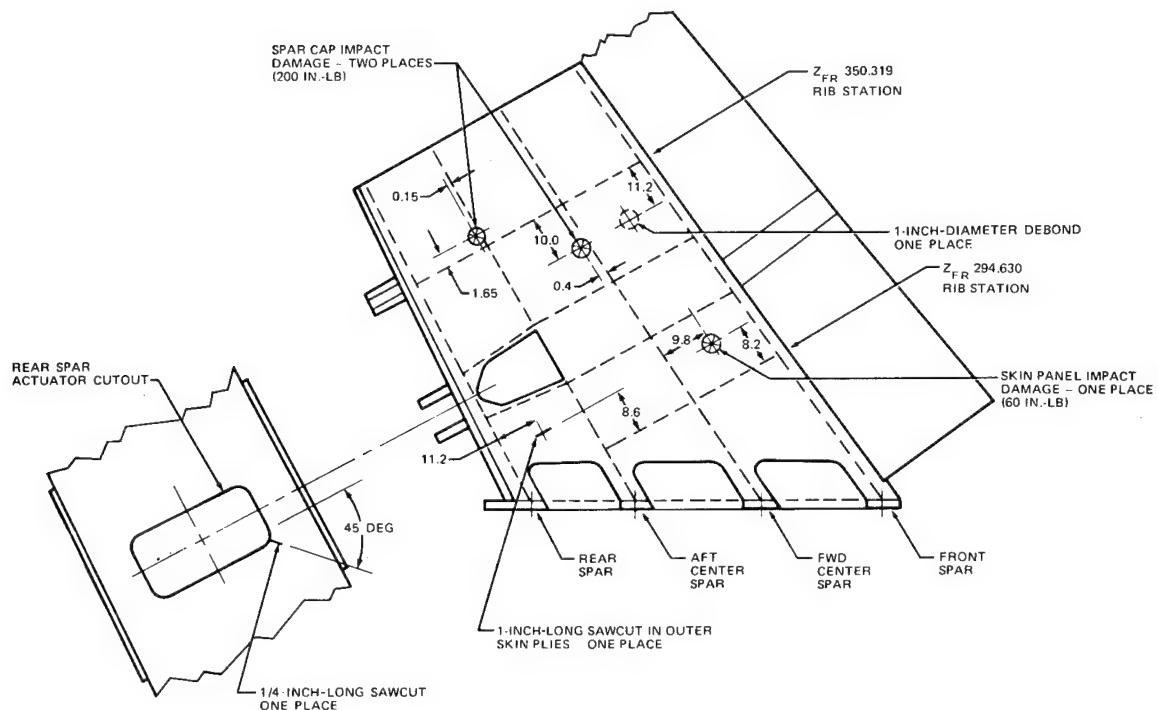
FIGURE 9.

Following the completion of the fail-safe testing and prior to the second fatigue spectrum test, damage was inflicted on the structure as shown in Figure 9. Impact damage was inflicted on the thick spar cap laminate in two locations and in the center of a skin panel bay in one location. A one-inch-diameter debond and a one-inch-long sawcut were made in two other skin panel bays. A 1/4-inch-long sawcut in the corner of the rear spar actuator cutout completed the inflicted damage. Each damage site was inspected ultrasonically to determine the extent of damage not apparent by visual examination. Testing was then resumed and continued through the end of the second life-cycle fatigue spectrum test. None of the damaged areas exhibited any damage growth except for the impact damage to the aft center spar cap at  $Z_{FR}$  station 352. NDI checks during the test indicated that the damage in this location increased in size by approximately 40 percent over the initial damage by the end of 21,000 flights (1/2 lifetime). Post-test visual and NDI inspections indicated no further damage growth.

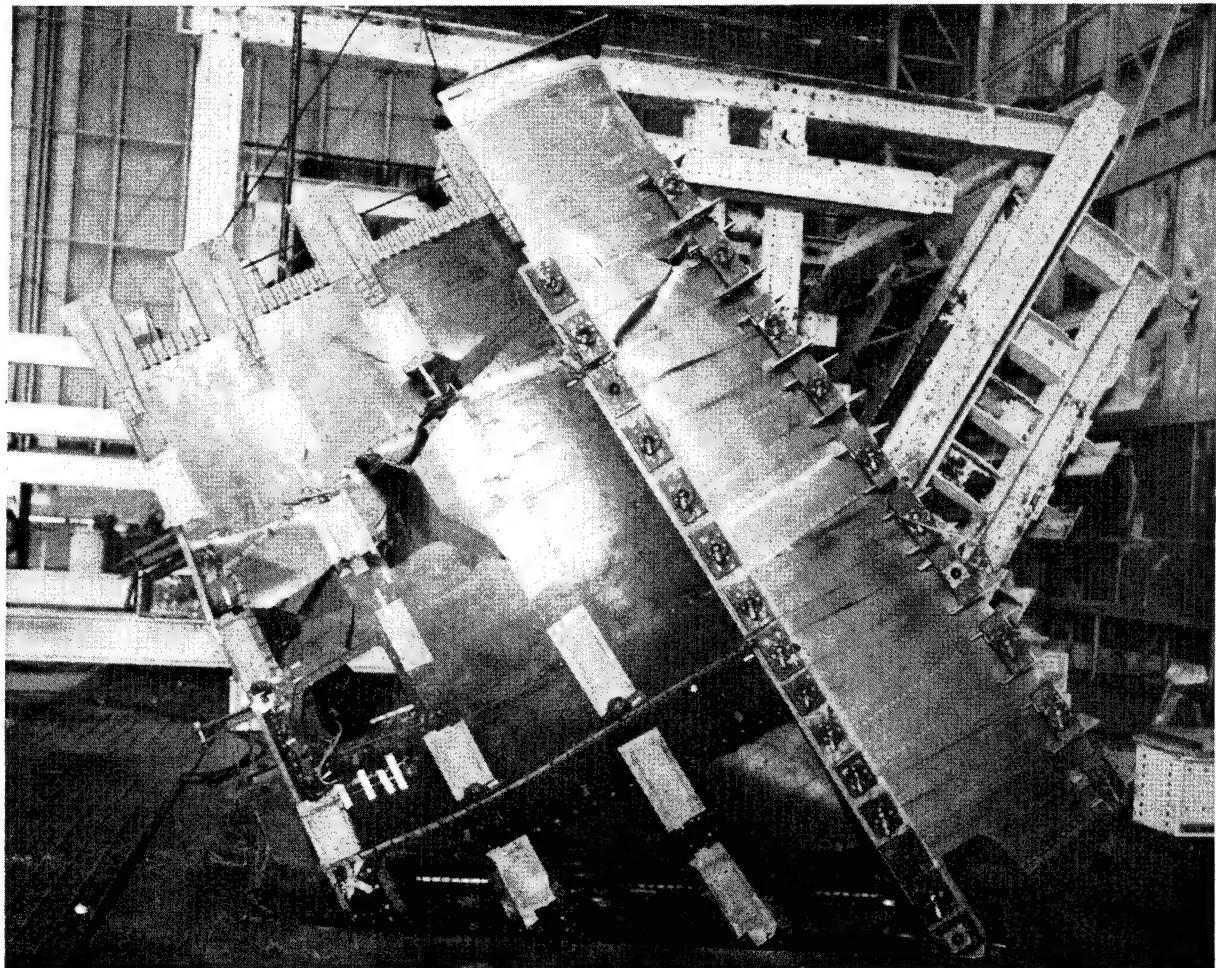
FIGURE 10.

During the residual strength test, loading continued to 144 percent of design limit load (96 percent of design ultimate) when failure occurred suddenly on the compression side. Figure 10 shows the failures in the right skin and leading edge. Although there was no requirement to obtain any specific load level at failure, this failure was considered somewhat premature in that: (1) an undamaged structure would not be expected to fail before reaching 160 percent design limit load, and (2) none of the observed failures occurred through the damaged areas or in the high strain regions in the actuator cutouts.

Posttest investigations revealed that failure originated in the rear spar web at the lower access opening at  $Z_{FR}$  station 342. The failure was attributed to high stress concentrations at the edge of the access opening as a result of improper fit in the fasteners attaching the load-carrying access covers to the spar webs. This mode of failure as well as the sequence of failure through the structure were validated by finite-element analysis. The cause of failure was also verified by tests on a representative test panel.

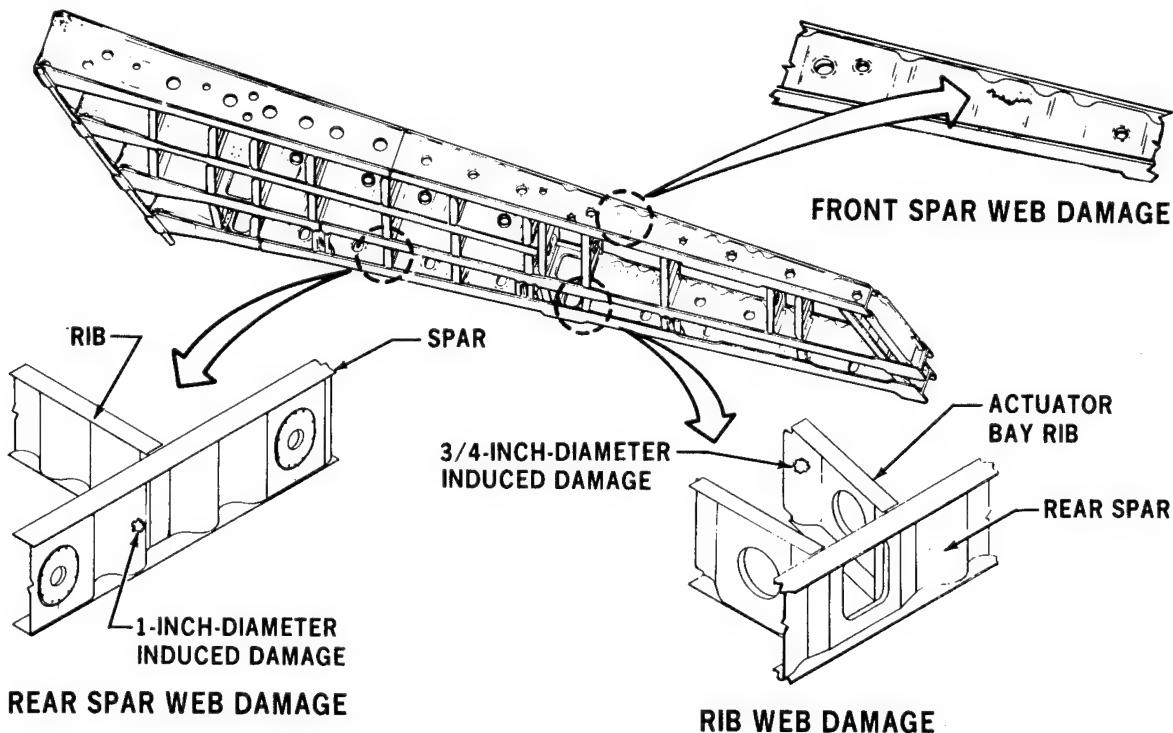
FIGURE 13.

Following the ultimate load test, the test setup was revised in preparation for the second life-cycle fatigue test. Before this test was conducted, impact damage was inflicted in the rear spar web at  $Z_{FR}$  station 370 and in the web of the AMC7880-5 rib in the upper actuator bay. These locations are indicated in Figure 13. The intent was to inflict a type of service-related damage that might occur in performing maintenance tasks on rudder actuators or hinge brackets.

Subsequent evaluation of strain data from the ultimate load test revealed that a failure (crack) had occurred in the front spar web approximately 7 feet from the tip. This was confirmed by a visual reexamination of the area after removal of the leading edge fairing at the conclusion of the test program. The data indicated that the failure had occurred at the time the noise was heard at 140 percent of design limit load. This failure is also shown in Figure 13.

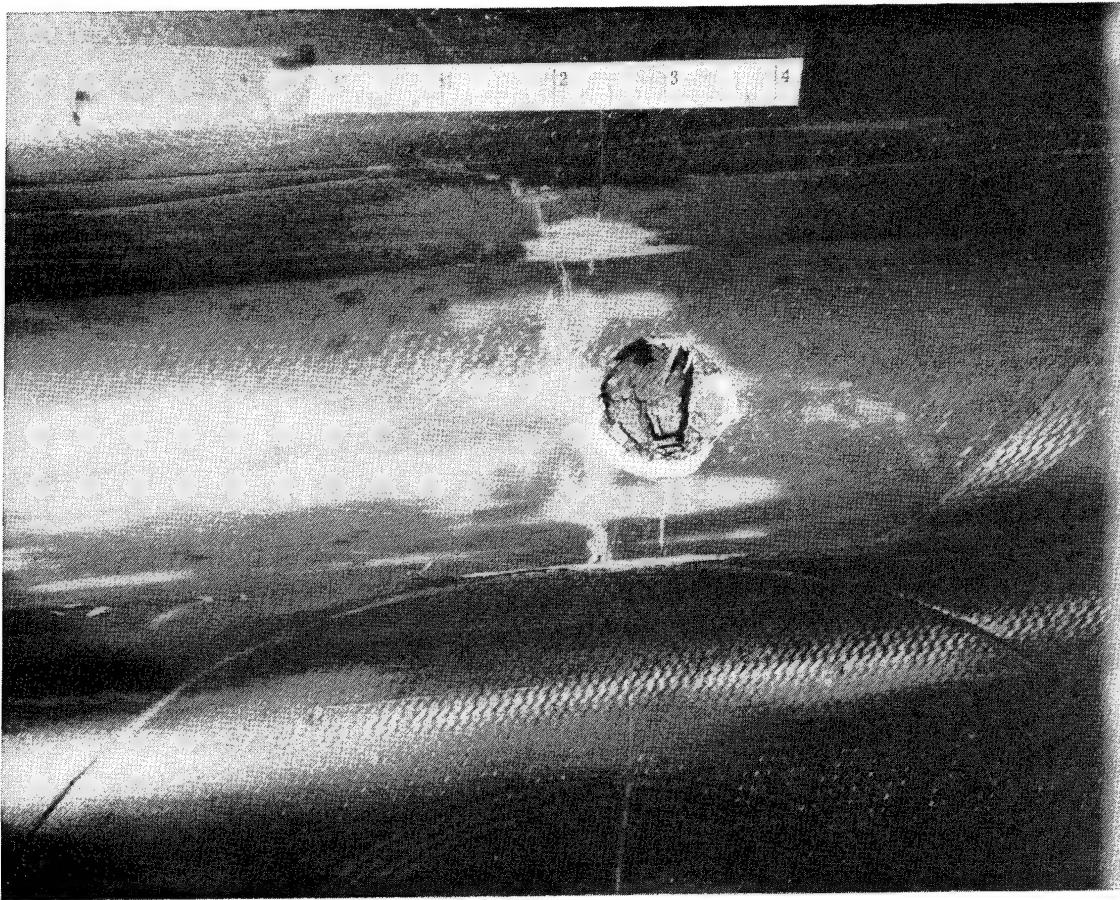
FIGURE 14.

The rear spar web damage was caused by a 1-inch-diameter blunt impactor driven through the web using a rivet gun, which resulted in a 1 inch by 2-1/2 inch broken and delaminated area around the impact site. The spar web damage is shown in Figure 14. The spar web in this area consisted of four plies of carbon/epoxy cloth laid up in a pseudo-isotropic pattern.

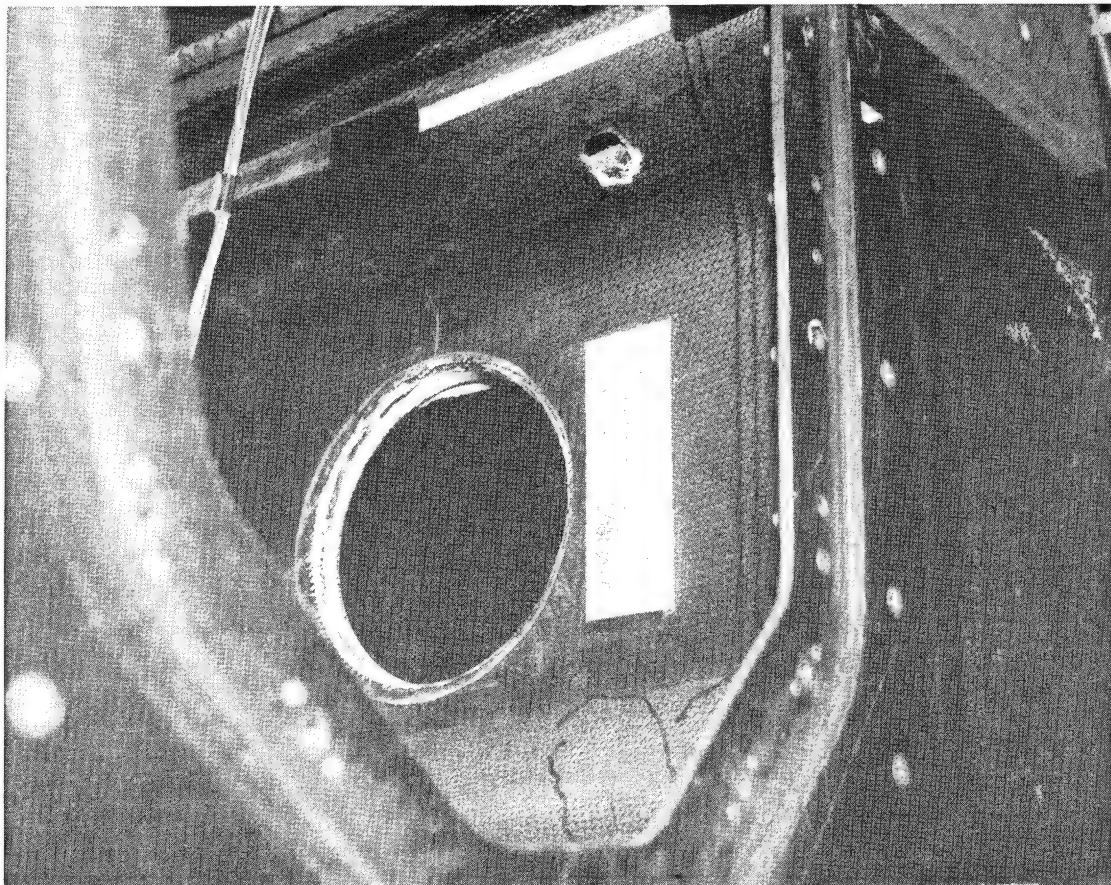
FIGURE 15.

The actuator bay rib damage was caused by a 3/4-inch-diameter sharp impactor. The rib web damage is shown in Figure 15. The rib web consists of two plies of carbon/epoxy cloth oriented at  $\pm 45$  degrees.

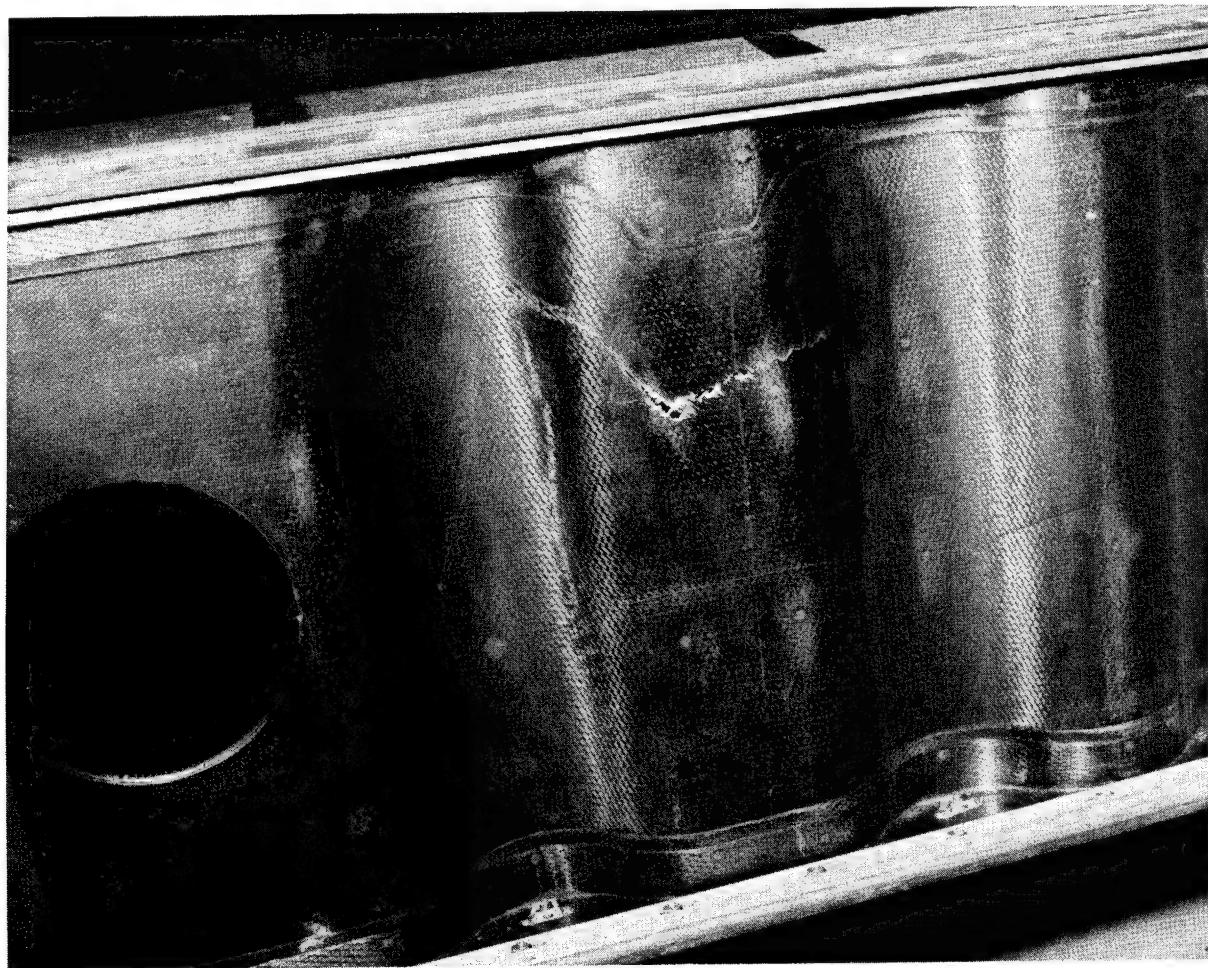
FIGURE 16.

Figure 16 shows the crack in the front spar web that occurred during the ultimate load test at 140 percent of design limit load.

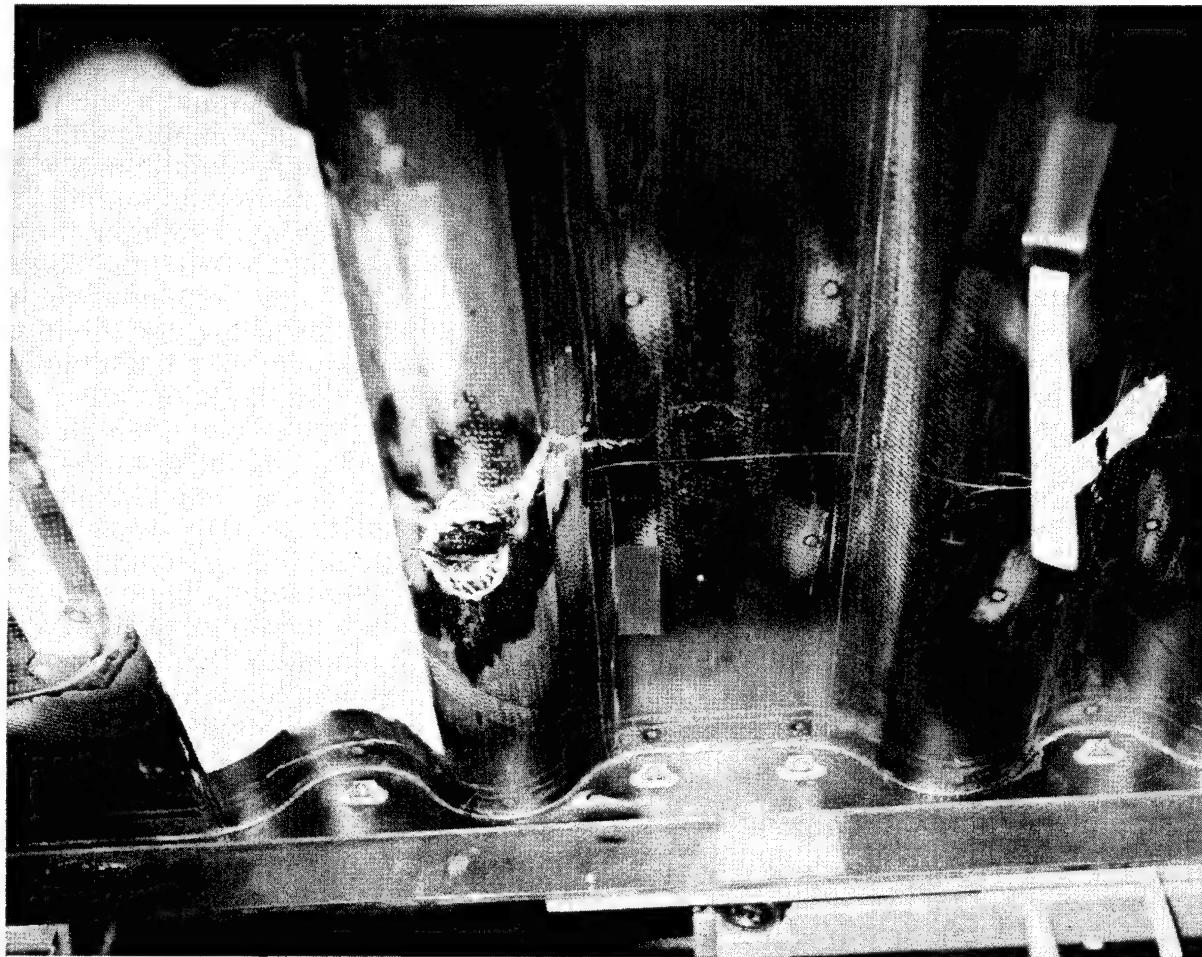
FIGURE 17.

The structure was loaded in a critical bending condition to 100 percent of limit load. At 97 percent of limit load, a fracture occurred through the damaged area in the rear spar. The loading was continued to 100 percent of limit load, then immediately removed so the crack could be inspected. The crack extended diagonally across the hole for approximately 8 inches. The upper crack tip arrested at the rib intersection and the lower crack tip stopped at a doubler buildup at an access hole. This damage is shown in Figure 17.

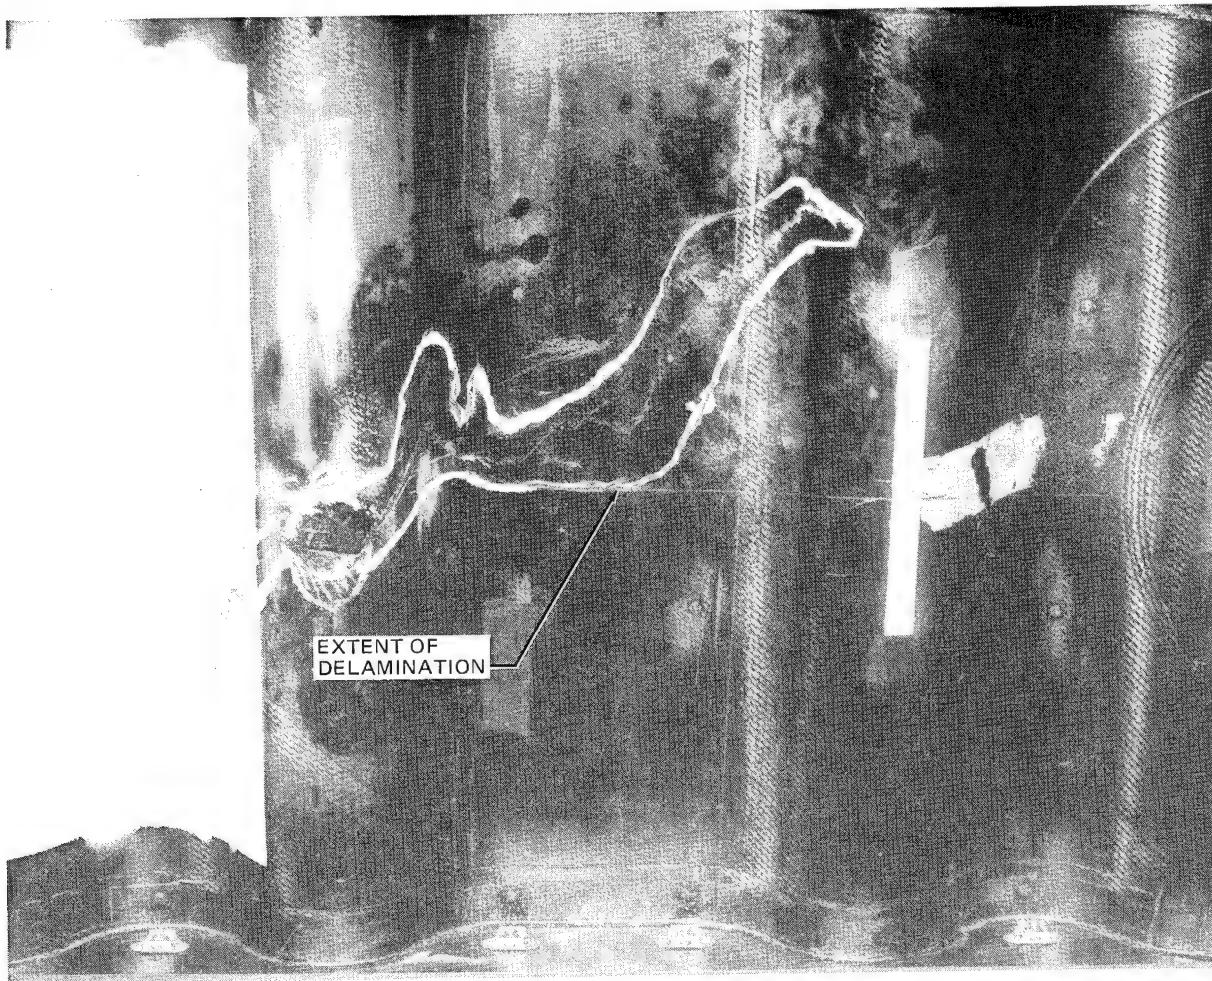
FIGURE 18.

Since the load was immediately removed at 100 percent of limit load after the fracture occurred, the test did not comply with the FAA requirements of a 3-second hold with a full load, and it was necessary to rerun the test. The retest represented a very severe test of the fail-safe capability of the CVS with major damage. This time, full load was held for the required 3 seconds. The crack grew but self-arrested and was stable during the hold period. Posttest visual inspection revealed that the crack grew an additional 5 inches toward the tip past the rib intersection and self-arrested in the middle of the next bay.

Ultrasonic inspection revealed that there were delaminations in the region of the crack. Figure 18 shows the final spar web damage with the delaminated area outlined with white paint. The initial 3/4-inch hole in the actuator bay rib did not change in size during the tests.

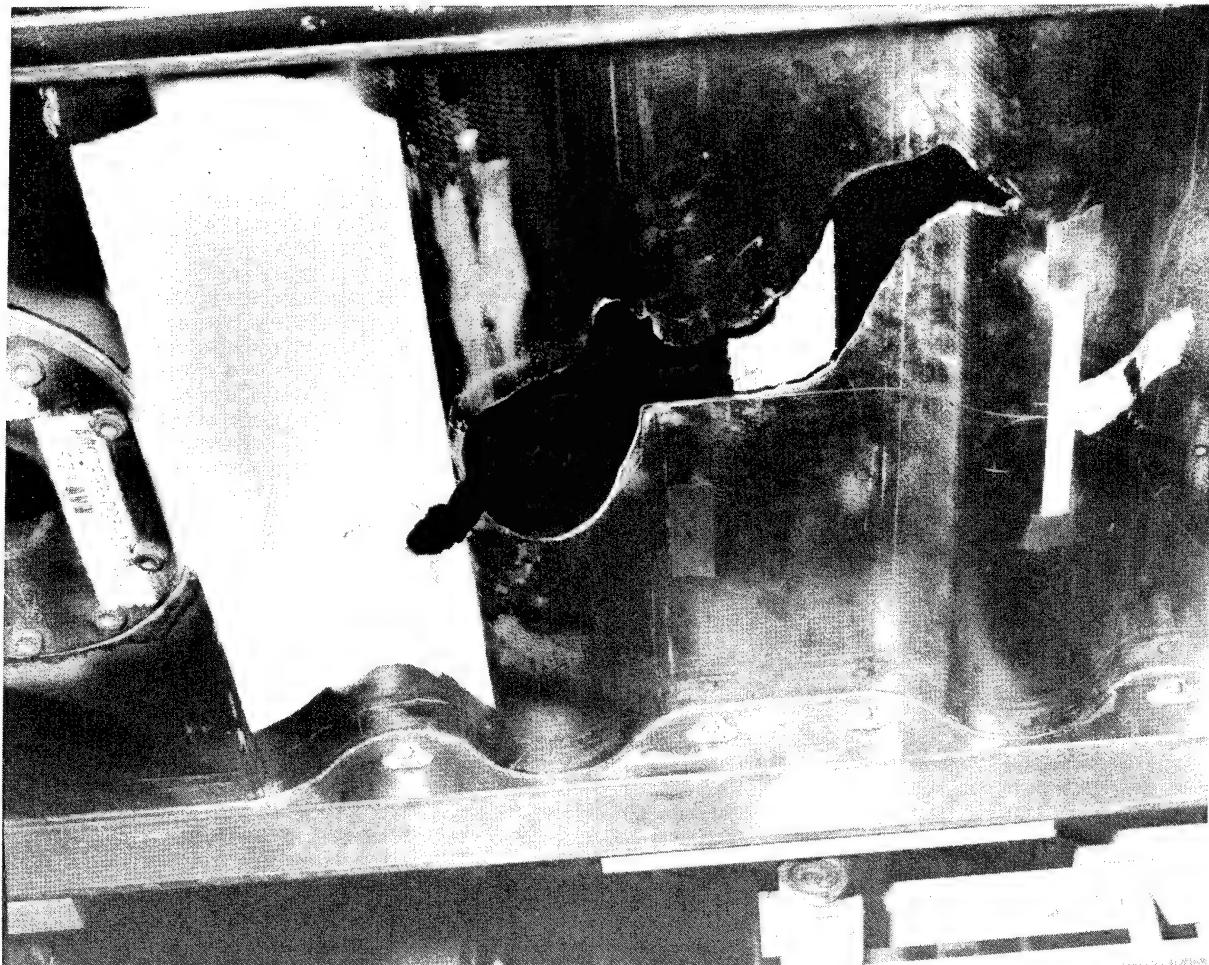
FIGURE 20.

The delaminated area around the crack was trimmed away, leaving an elongated slot which measured 12 inches by 2.5 inches (Figure 20). In addition to the visible damage, it was noticed that the rib-to-spar web attachment angle was separated away from the spar. To ensure that air would not leak through the bond line in this patch, a vacuum bag was used on both sides of the repair. This repair necessitated access to the back, so the two adjacent bonded and bolted access covers were removed, both above and below the damage. For convenience, these doors were subsequently replaced with aluminum doors.

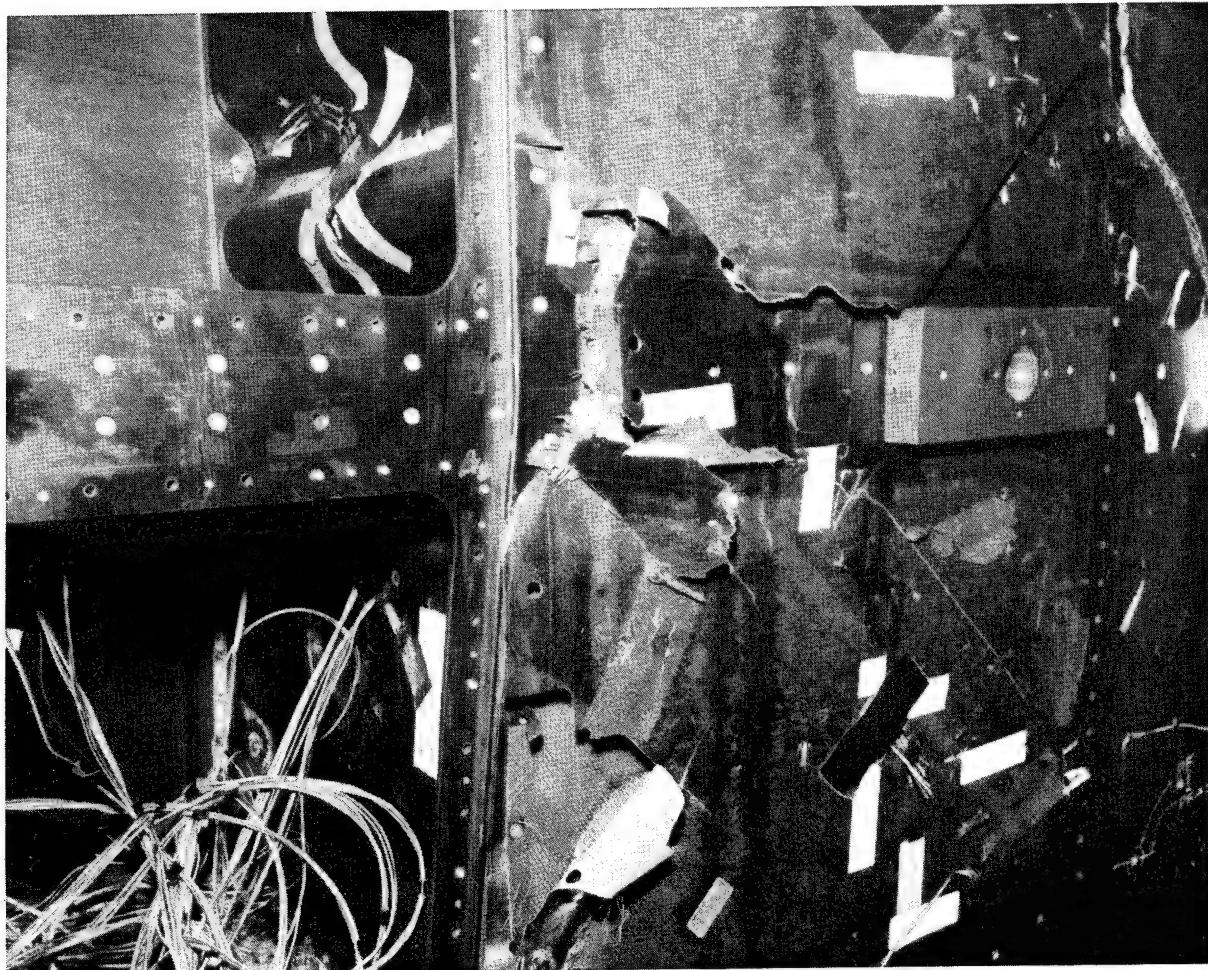
FIGURE 30.

The analysis predicted that the failure would occur in the aft center spar cap, directly through a double row of attachments (Figure 30). The strain gage record and high-speed film showed that within one data scan (1/60th of a second) or one film frame (1/48th of a second), the aft center spar cap, the spar web at the same location, and the skin panel directly forward had all failed.

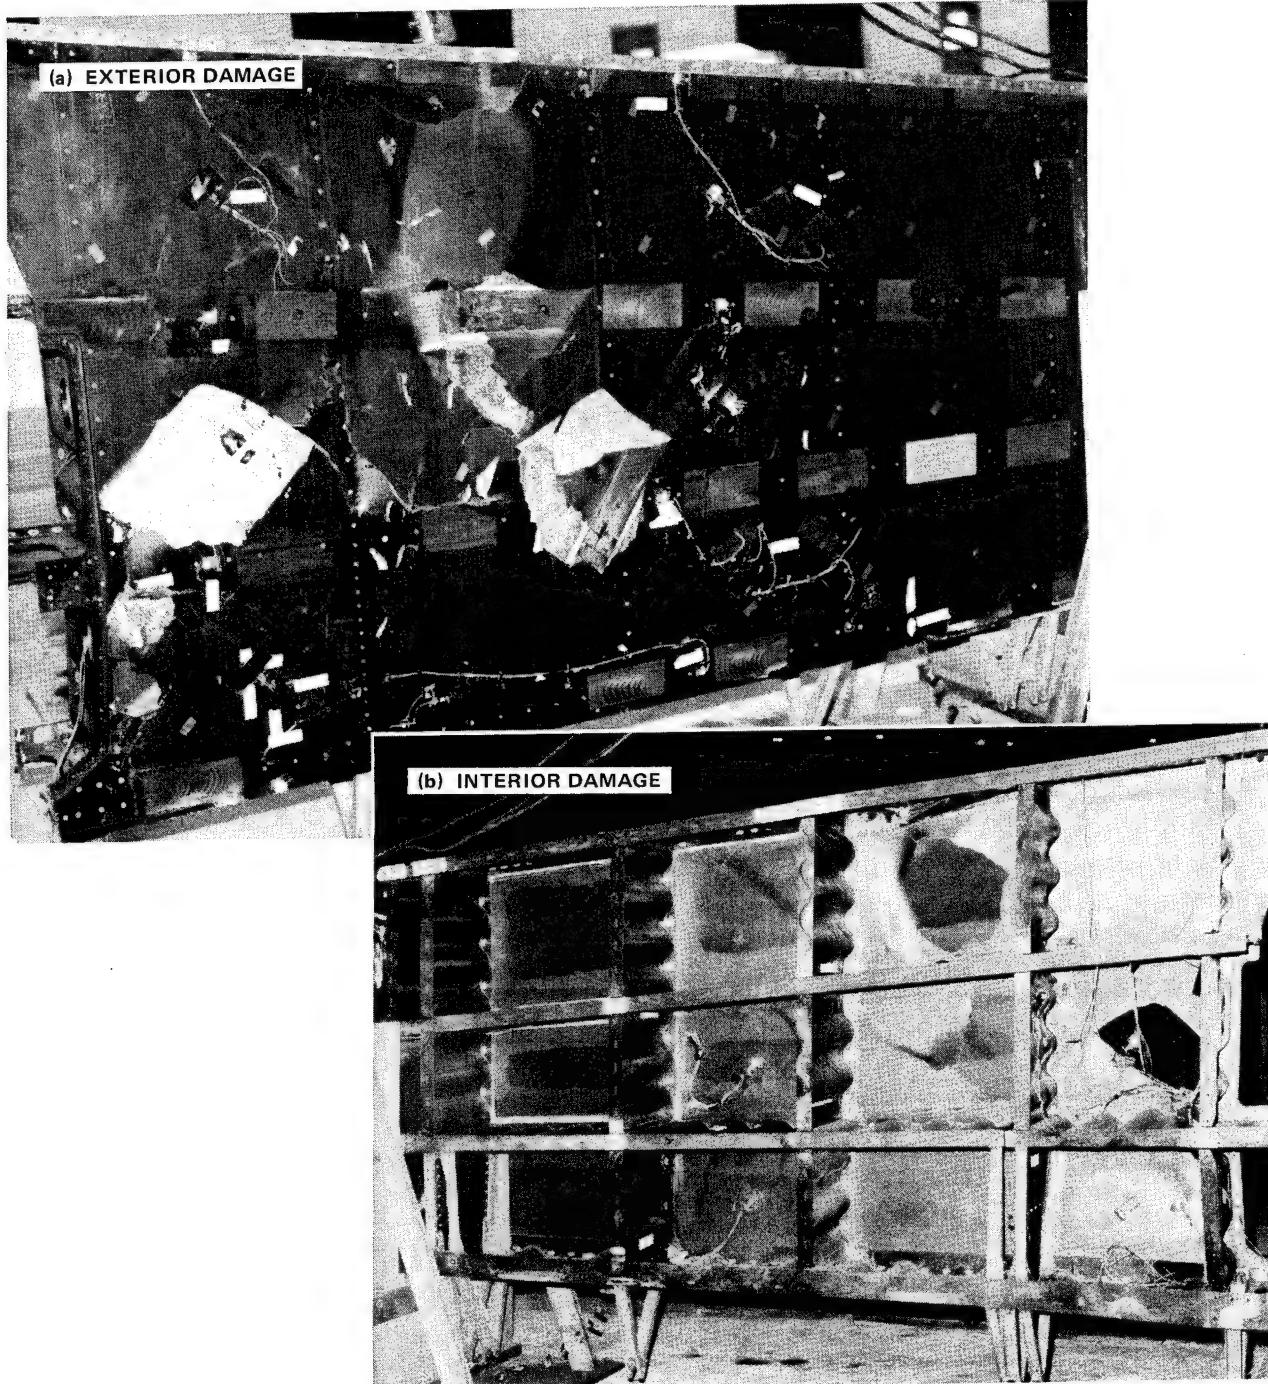
FIGURE 32.

Because of the direction of the shear flow already in the panels, each responds differently. The aft panel experiences essentially a reversal of its shear loading, with almost no effect on its margin of safety. The forward panel, on the other hand, experiences a tripling of its shear flow, which is instantly fatal. Figure 32 shows the central portion of this panel literally blown out of the structure, remaining attached only by the strain gage leads and the peel ply.

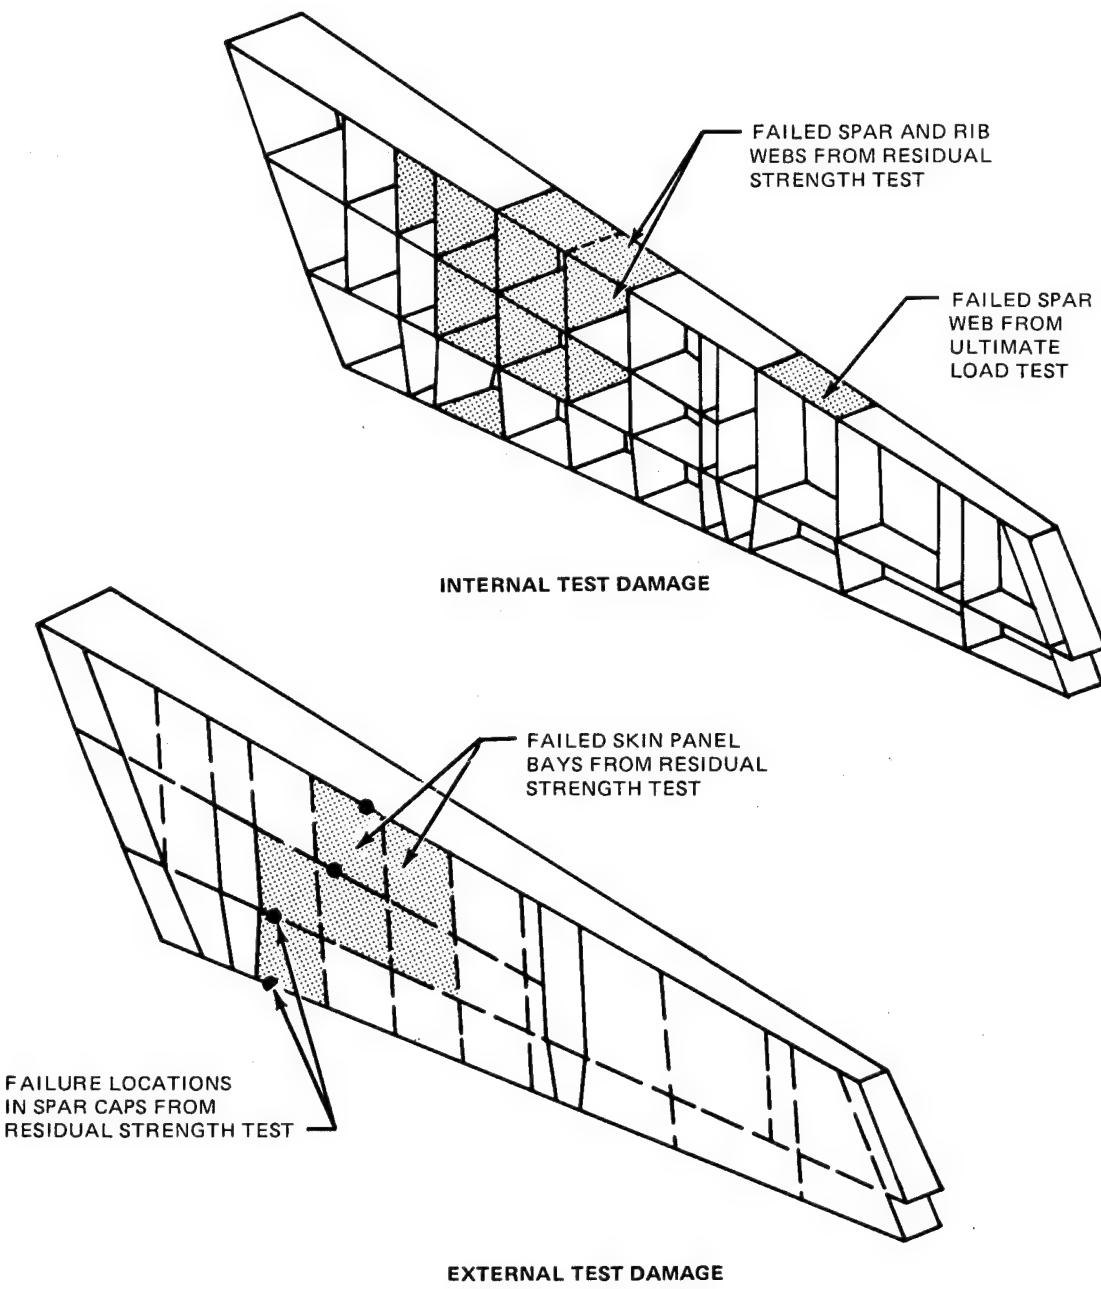
FIGURE 35.

The final extent of the test damage to the specimen is shown in Figure 35.

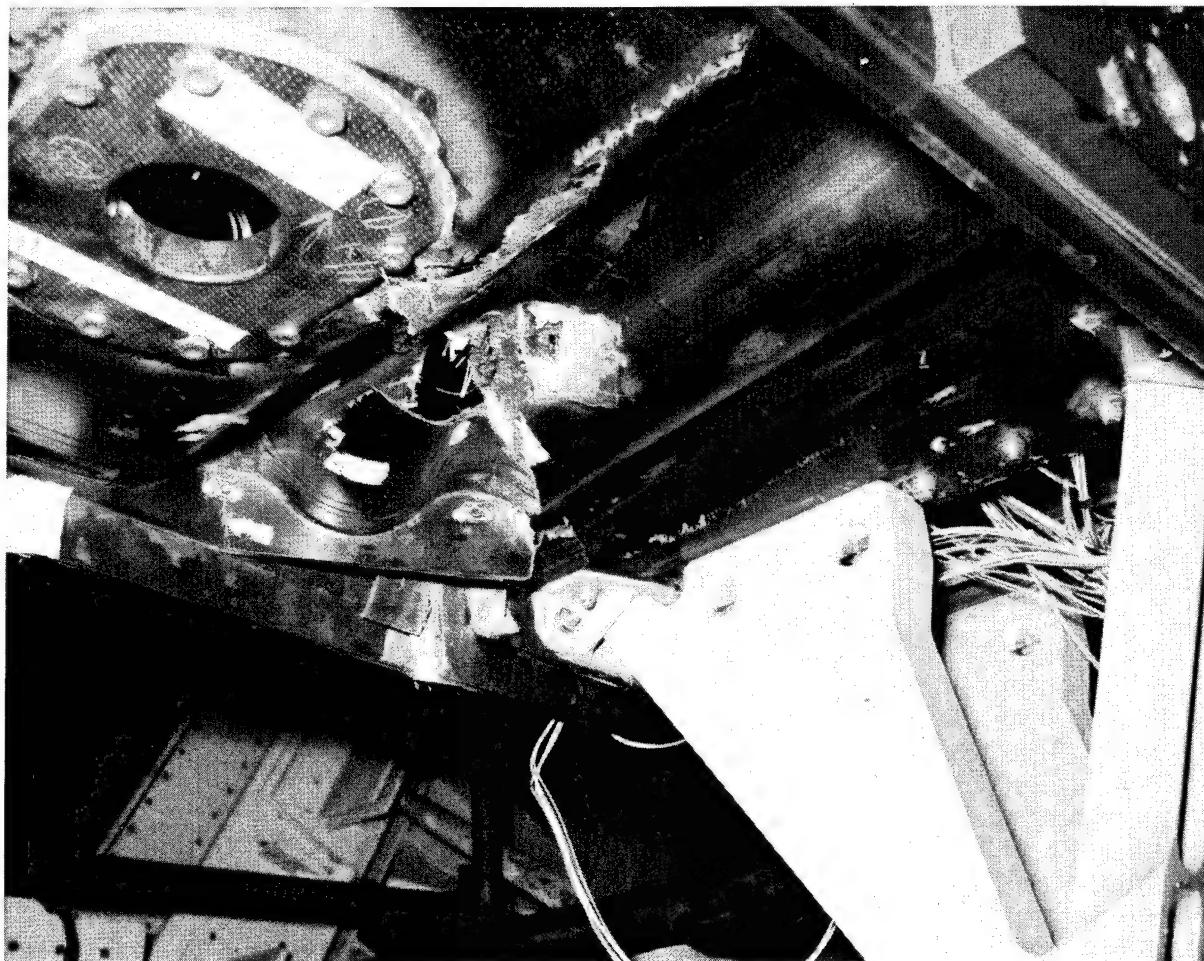
FIGURE 34.

Analytically, the next failure in the sequence would be expected in the rear spar cap. The test record shows that no further failures occurred for approximately 0.06 second. This may be attributed to the lag time of the loading system. Again, in one data scan and one film frame, essentially all of the remaining structural damage occurred. Following the failure of the rear spar cap and web (Figure 34), the damage was so extensive that no further attempt was made to establish sequence.
